Final Report

Study on Yamuna Frothing in Delhi

Department of Environment
Government of NCT of Delhi

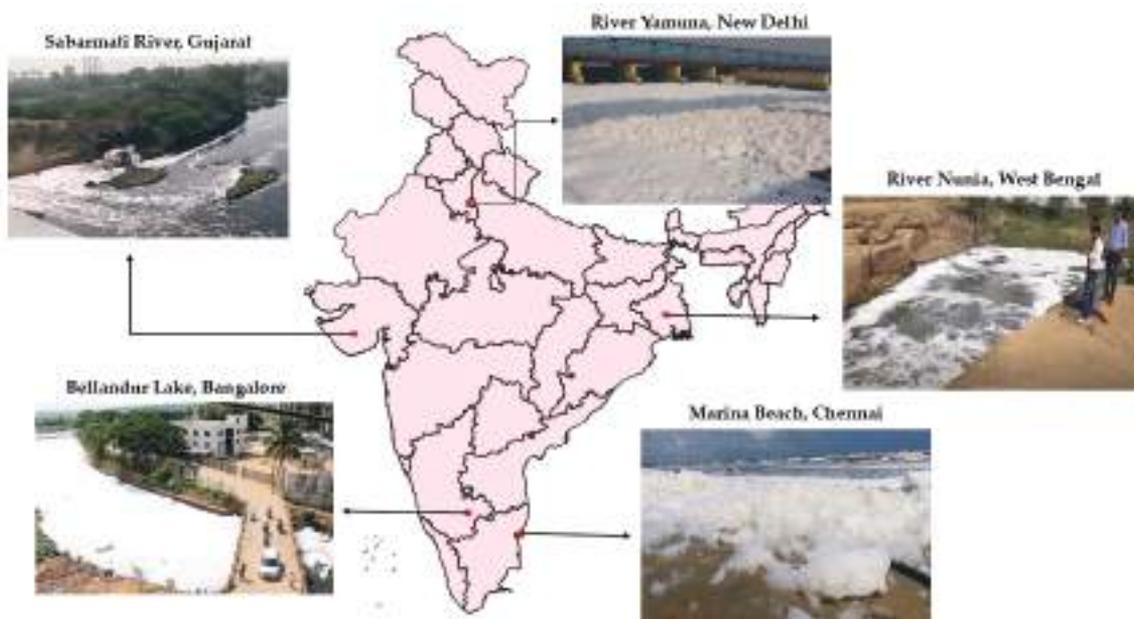
Figure 4: Foaming Incidents Reported in India

In India, foaming in rivers and lakes is increasingly being reported in major urban centers. Figure 4 shows few major incidents of foaming observed in surface water bodies in India

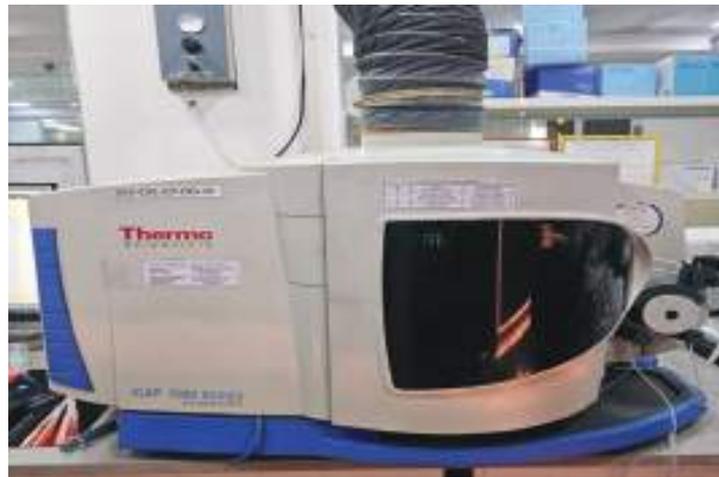
Figure 7: ICP-OES

1. **Thermo ICP-OES (Inductively Coupled Plasma – Optical Emission Spectrometer, iCAP 7000 Series)** for trace metal and nutrient analysis (Phosphates, STPP, Heavy Metals).

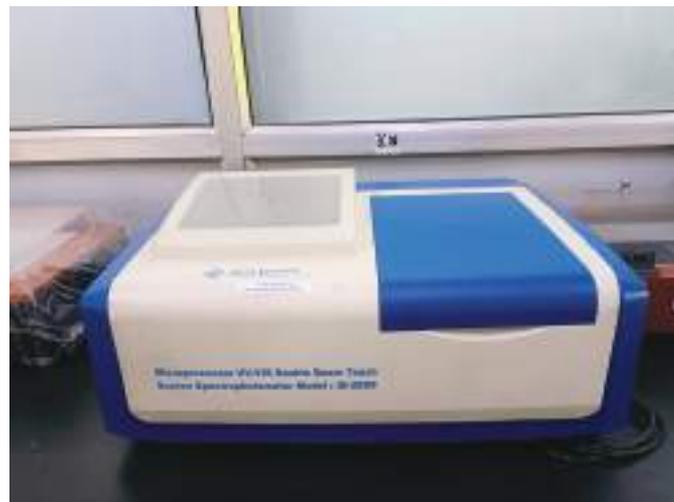
Figure 8: Ultraviolet-Visible spectrophotometer

2. **UV-Vis Spectrophotometer** for colorimetric determinations

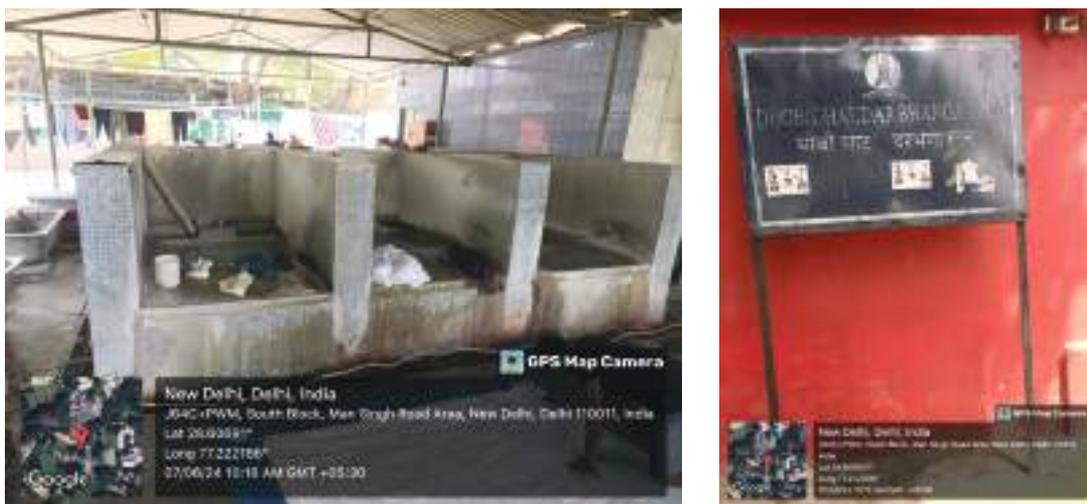
Figure 11: Darbhanga Dhobi Ghat, near Man Singh Road Area

Category A includes Darbhanga Dhobi Ghat (Figure 11) and Lodhi Colony Dhobi Ghat (Figure 12). Samples were not taken from these Dhobi Ghats because the wastewater here has been discharged into the tapped drains, reducing the likelihood of direct environmental contamination. These tapped drains are directed to nearby STPs where the treatment might take place.

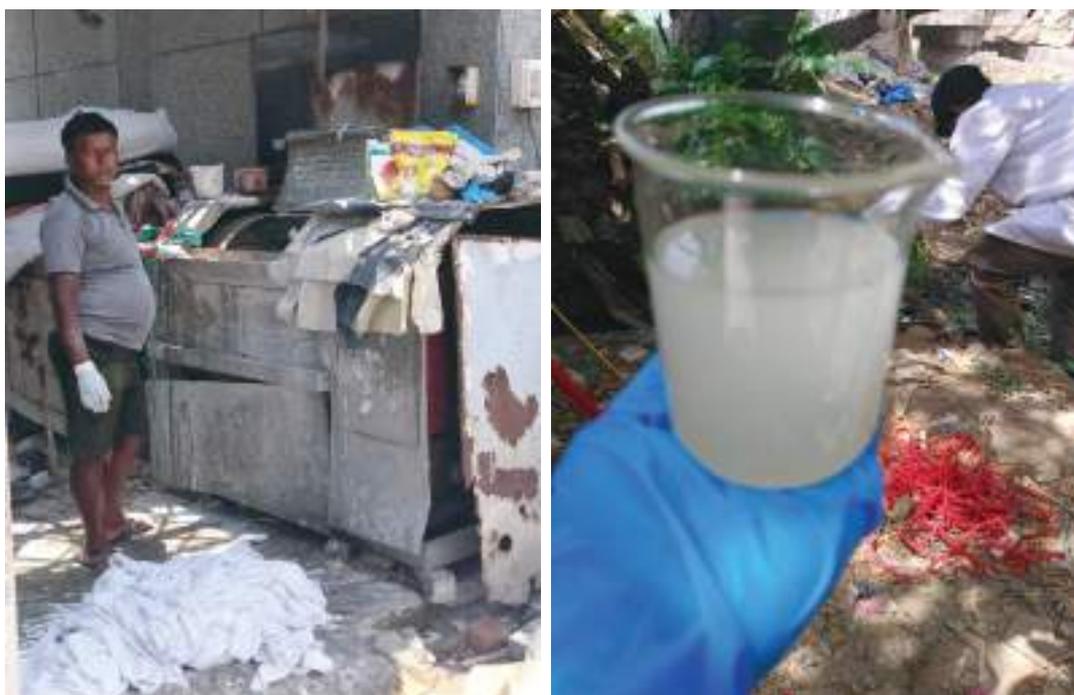
Figure 13: Akshardham Dhobi Ghat, Patparganj

Category B includes Akshardham Dhobi Ghat (Figure 13), and Khichdipur Dhobi Ghat (Figure 14) and Railway Colony Dhobi ghat (Figure 15) where samples were taken from these Dhobi Ghats because the detergent-rich wastewater was directly falling into the open drains which ultimately make their way to River Yamuna. The effluent from Khichdipur Dhobi Ghat flows into the Shahdara Drain. The wastewater from Akshardham Dhobi Ghat is released into the Yamuna River via the Ganesh Nagar Drain, eventually flowing into the Hindon Cut Canal. Railway colony dhobi ghat was found connected to the Drain 12 A that meets Yamuna River after Chhath ghat.

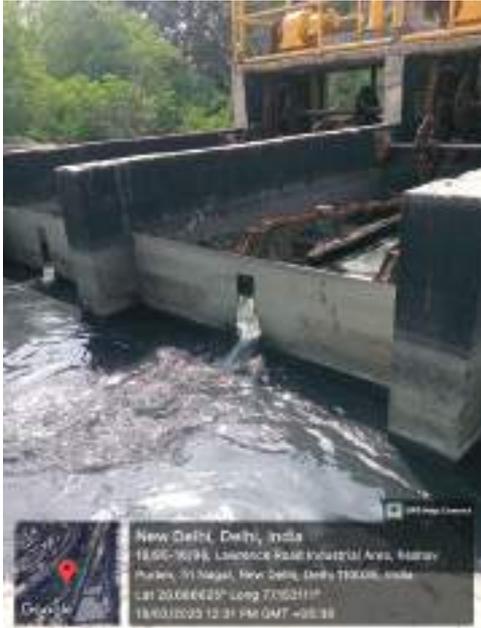
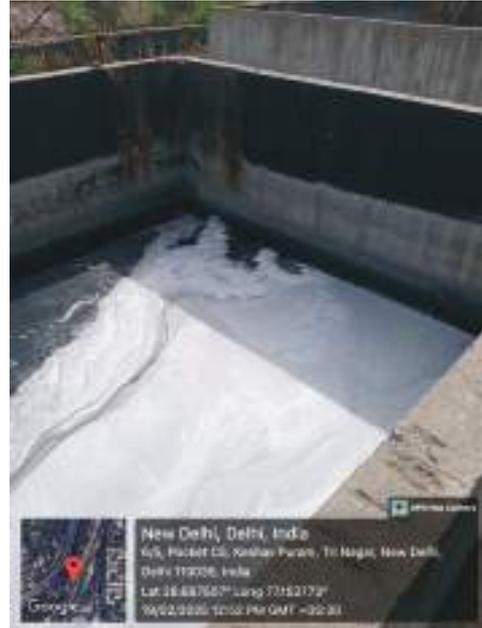
1. Lawrence Road CETP:

The CETP demonstrates generally effective treatment performance across key parameters; however, selective infrastructure strengthening and the addition of targeted tertiary treatment units would help address residual surfactants and further enhance effluent quality in response to evolving industrial discharge characteristics.

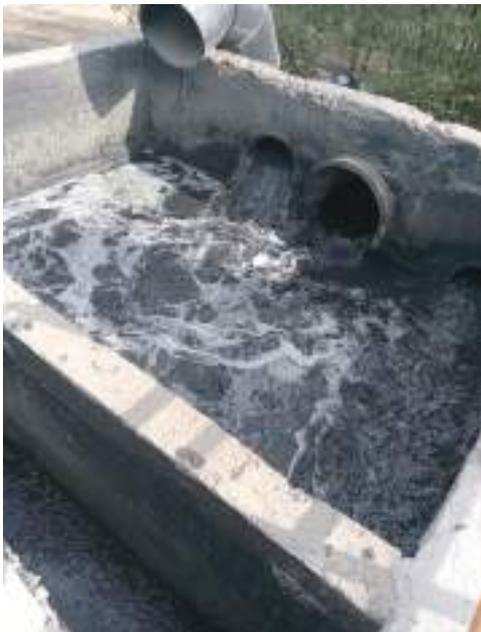
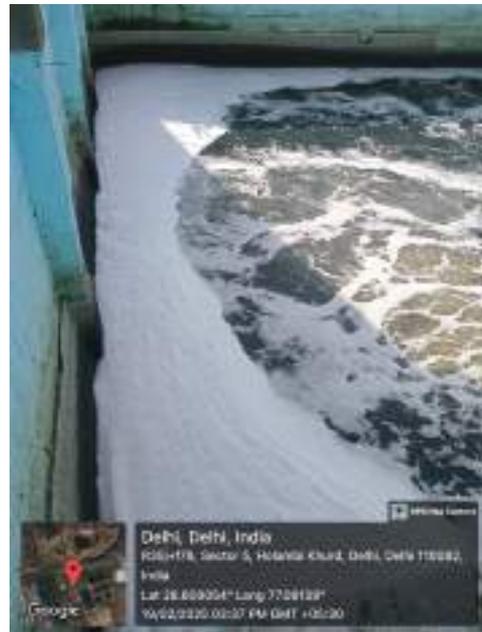
2. Bawana CETP:

The presence of visible foaming at the outlet, coupled with low experimental removal efficiencies for surfactants and STPP, clearly indicates a treatment gap. Integrating surfactant-targeted tertiary technologies such as activated carbon polishing, advanced oxidation processes (AOPs), or specialized membrane systems would significantly improve effluent quality and effectively address persistent foam-forming contaminants in the discharge.

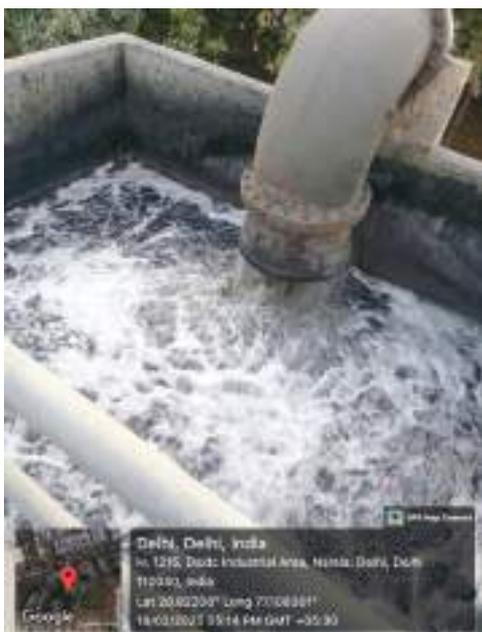
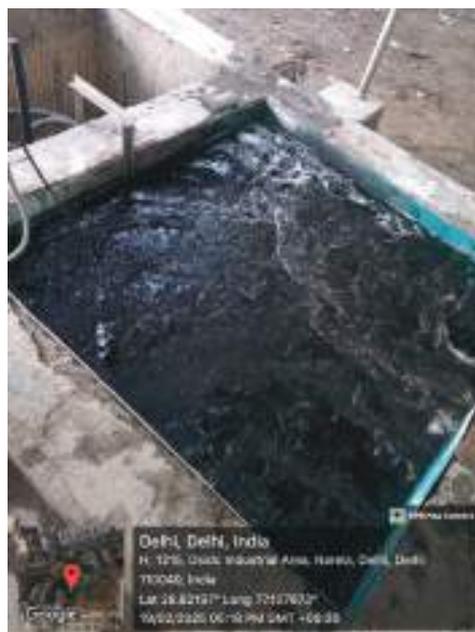
3. Narela CETP:

While the CETP performs strongly in removing organic matter and pathogens, the low removal of surfactants and STPP indicates a gap in advanced treatment capability. Integration of targeted tertiary units such as activated carbon adsorption, advanced oxidation processes, or membrane-based polishing would enhance the removal of persistent surfactant fractions and reduce the risk of downstream foaming in the river.

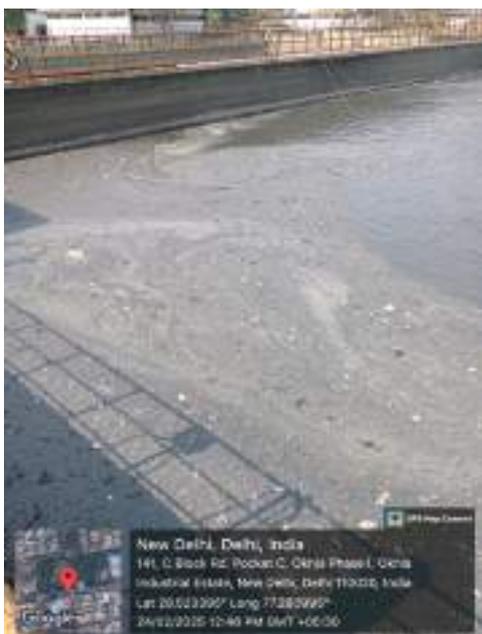
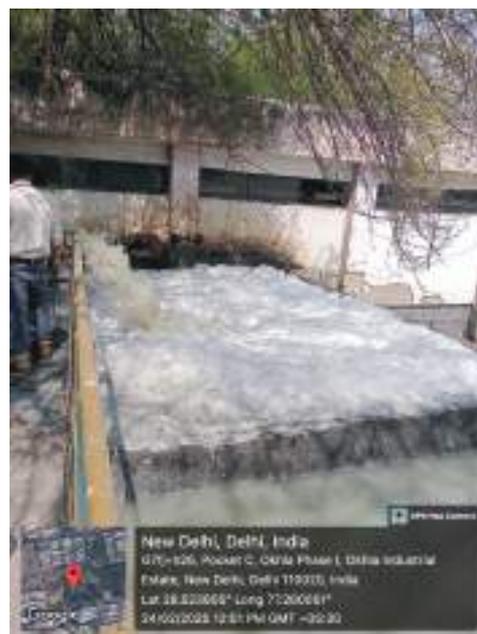
4. Okhla CETP:

Although the CETP demonstrates satisfactory removal of pathogens and phosphates, its performance in treating ammonia and surfactants is significantly inadequate. The combination of low nutrient and surfactant removal, high influent loading, and visibly deteriorated infrastructure indicates that the existing treatment processes are insufficient for current effluent characteristics. Upgradation of treatment units and integration of targeted tertiary processes such as nitrification enhancement and surfactant-specific polishing are essential to improve overall treatment efficiency and address persistent foaming at the outlet.

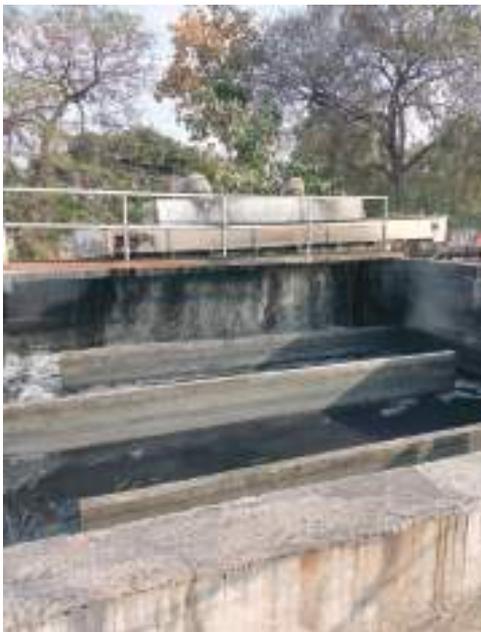
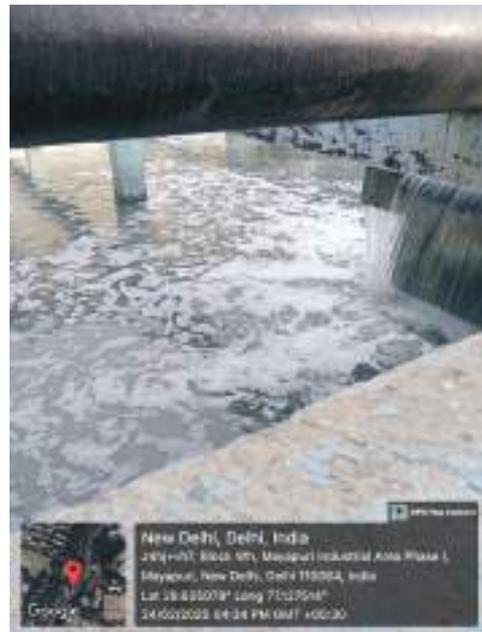
5. Mayapuri CETP:

While the CETP demonstrates strong F. Coli removal and relatively better performance for cationic surfactants and STPP, overall treatment efficiency remains inconsistent. Moderate BOD and COD reduction, limited ammonia removal, and variability in surfactant treatment indicate the need for infrastructure strengthening, improved operational control, and integration of targeted tertiary processes to enhance overall treatment reliability.

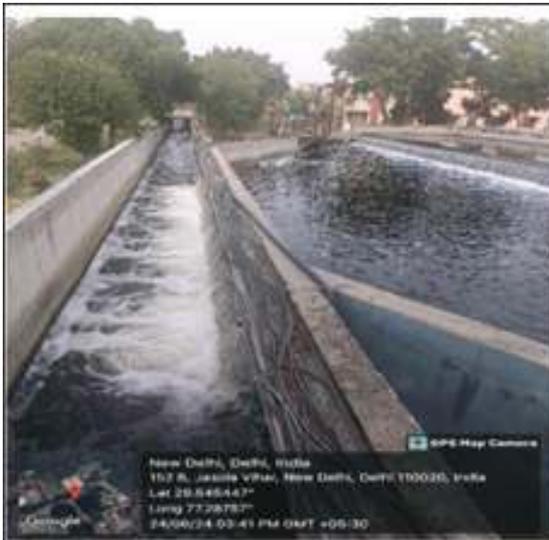
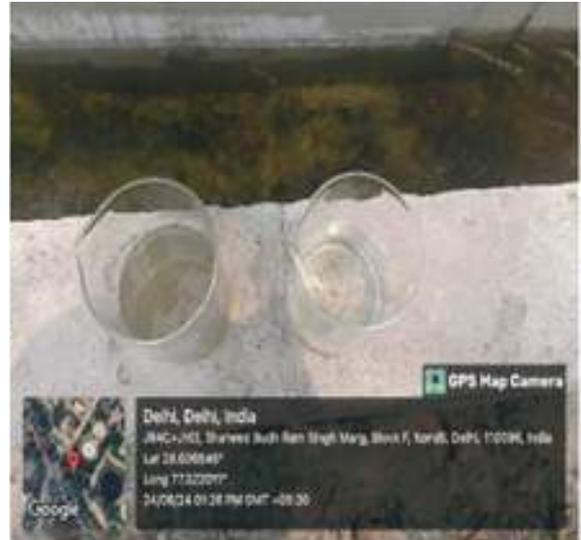
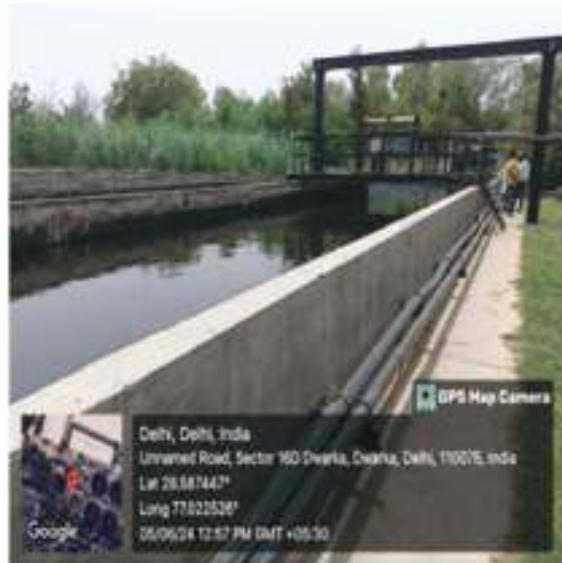
Figure 20: Sampling at STPs in Pre-Monsoon

Four major STPs have been selected i.e., Kondli STP, Okhla 30MGD STP, Dwarka STP Phase 2, and Najafgarh STP, and the treated water has been collected from their respective outlet. Samples were analyzed for standard parameters as well as for the parameters of concern. The sampling locations are marked on the map as shown in Figure 19. The details and pictures of sampling locations are given in Figure 20.

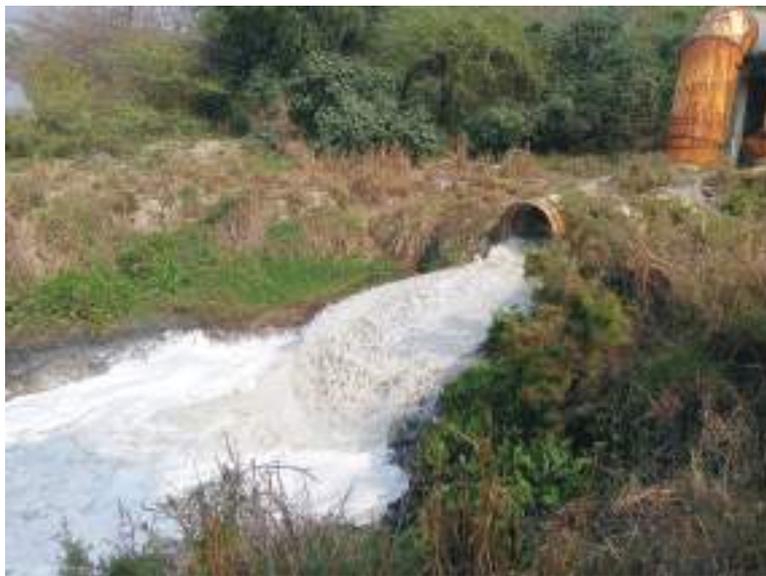
Figure 24: Treated Effluent from Yamuna Vihar STP being discharged in Yamuna

The Yamuna Vihar STP has been developed in three phases, with Phase I having a capacity of 10 MGD, Phase II 10 MGD, and Phase III 25 MGD. The treated effluent from this STP is discharged into the downstream stretch of the Yamuna River. During the field visit, it was observed that the outlet was releasing foaming water into the river, indicating possible issues with treatment efficiency or the presence of surfactants, as shown in Figure 24.

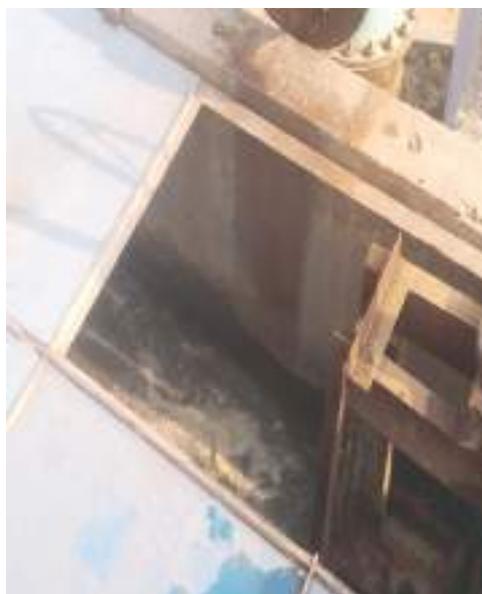
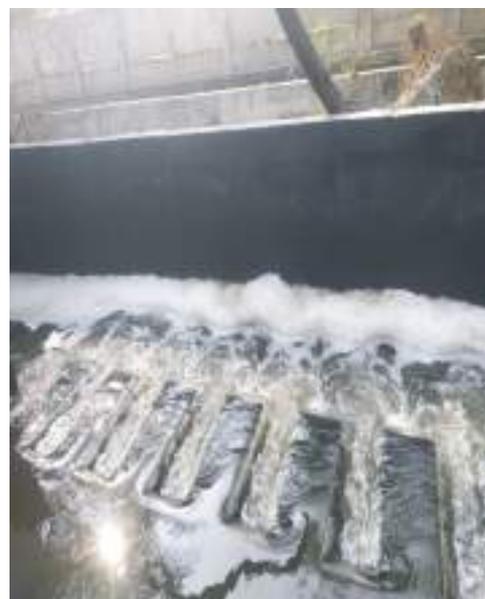
Figure 26: Inlet and outlet of Yamuna Vihar STP Phase-II

The inlet and outlet sample analysis of the STP is provided in Figure 26. The inlet BOD/COD ratio is 0.27 having COD 504.8 mg/L at the inlet, indicating significant intrusion of inorganic load from nearby industries.

- i. Grease and oil trap mechanisms found inadequate, possibly contributing to surfactant-rich wastewater entering biological treatment stages
- ii. The settling tank showed signs of poor sludge removal and surface scum accumulation
- iii. Poor retention time and improper desludging frequency noted.
- iv. Frothing was observed at the outlet indicating inefficient phosphate and surfactant removal
- v. Signs of aging infrastructure were evident across the facility, pointing to the need for rehabilitation or upgrading efforts.

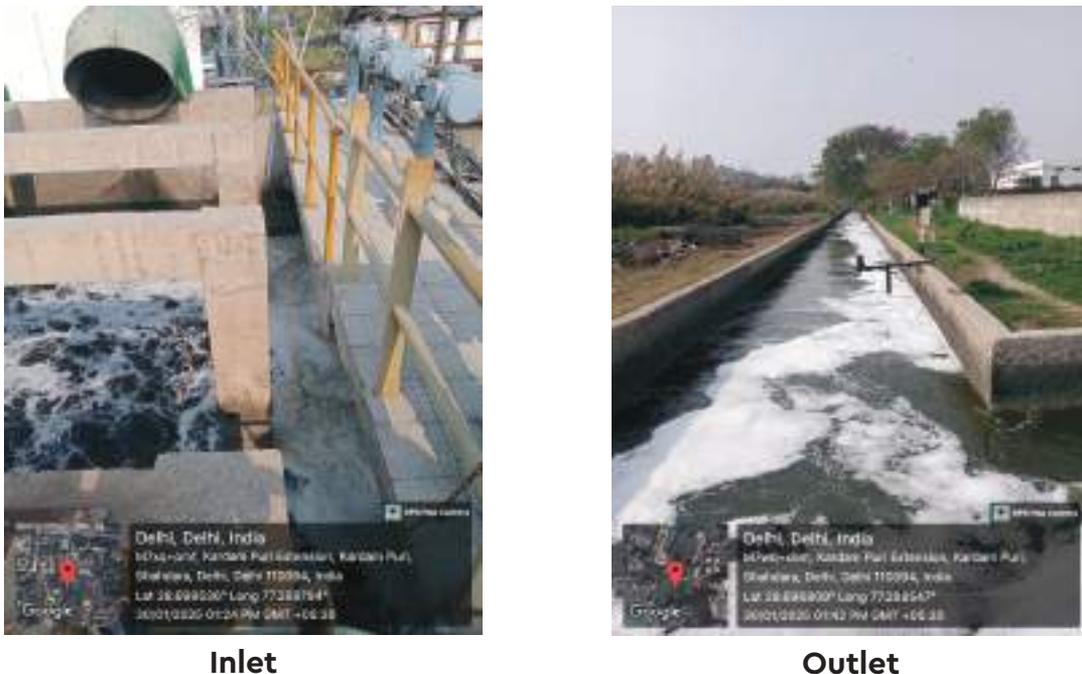
Figure 27: Inlet and outlet of Yamuna Vihar STP Phase-III

The inlet and outlet sample analysis of the STP is provided in Figure 27.

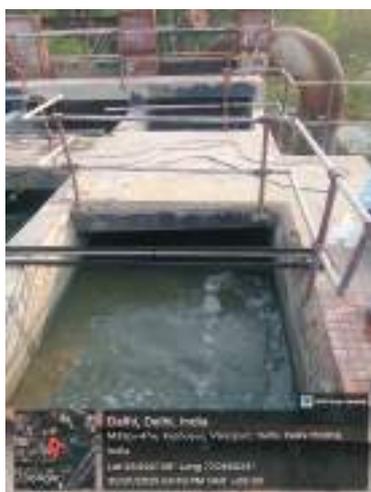
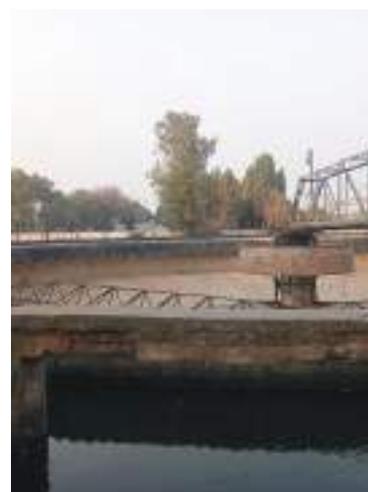
Figure 28: Inlet and Outlet of Keshopur STP

The inlet and outlet sample analysis of the STP is provided in Figure 28. The inlet BOD/COD ratio is > 0.3 , indicating that the sewage is primarily of domestic origin and does not show any significant intrusion of inorganic load from nearby industries.

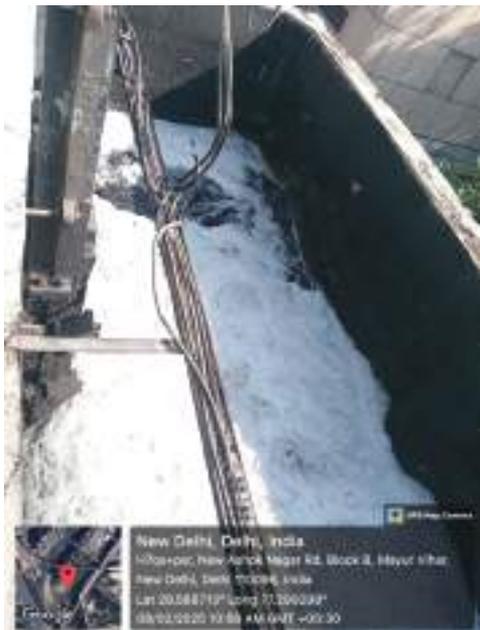
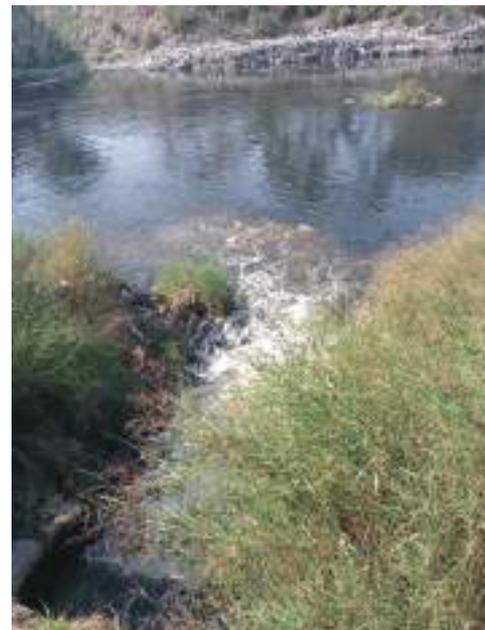
Figure 29: The Inlet and Outlet Sample Analysis of the STP

Inlet

Outlet

- i. The high removal efficiency of BOD (97%) and COD (96%) indicates effective degradation of organic matter through the treatment process.
- ii. Ammonia removal is highly efficient (99%), while nitrate removal remains moderate (34%), suggesting limited denitrification.
- iii. The treatment shows excellent performance in removing surfactants, with complete elimination of both anionic and cationic types.
- iv. Nutrient removal is partial, with phosphate and STPP removal at 51%, indicating a need for chemical or advanced treatment to enhance nutrient reduction.
- v. Fecal coliform removal is satisfactory, reflecting adequate disinfection efficiency.

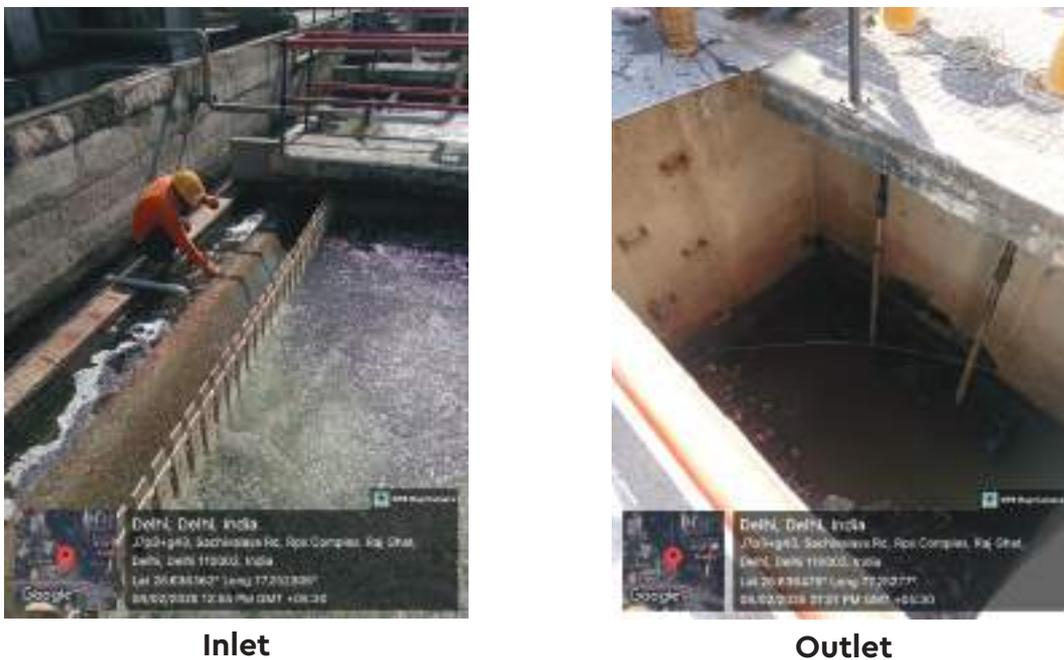
Figure 30: Inlet and Outlet of Delhi gate STP

The inlet and outlet sample analysis of the STP is provided in Figure 30.

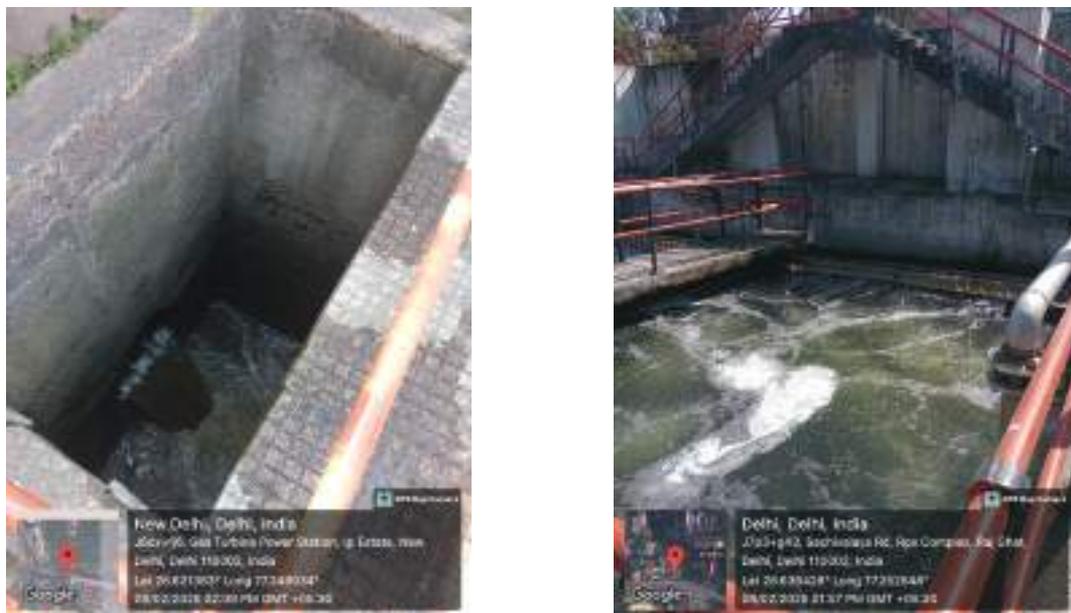
Figure 31: Inlet and outlet of Sen-nursing home STP

Inlet

Outlet

The inlet and outlet sample analysis of the STP is provided in Figure 31.

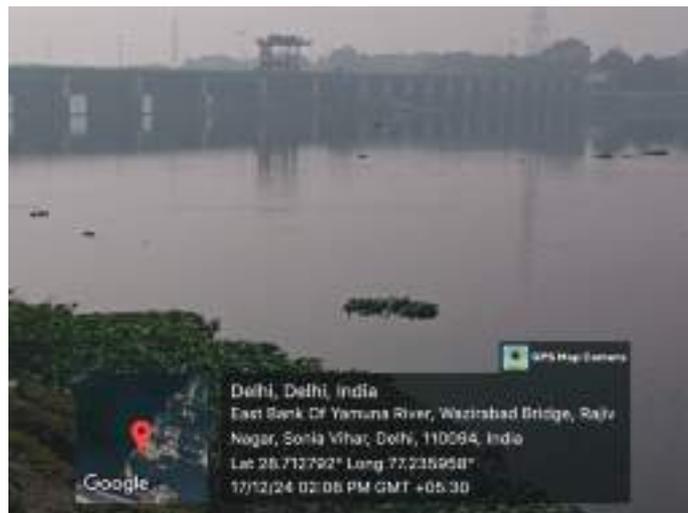
Figure 42: Post monsoon sampling at Upstream Wazirabad barrage (East)

Post-monsoon

Along a 22 km stretch of the Yamuna River flowing through urban Delhi, various key locations were selected to assess water quality and the impact of drain intrusions. The first sampling site was just upstream of the Wazirabad Barrage, where the river enters urban Delhi, followed by the downstream of the Wazirabad barrage. It was noted that the upstream section of the barrage was covered with water hyacinth, with minimal water flow through the barrage gates. The next sampling location was Hathi Ghat, also known as Qudsia Ghat, where the intrusion of the Mori Gate drain was observed downstream. The subsequent sampling took place at Chhath Ghat, near the ITO Bridge. The Delhi Gate drain falls at the upstream of Chhath Ghat. Both Hathi Ghat and Chhath Ghat showed significant visible pollution from plastic and other solid waste accumulation, primarily due to religious activities, such as poojas and offerings made by locals into the river. The remaining locations at Okhla Barrage were upstream of Okhla Barrage and downstream of Okhla Barrage, as listed in Table 15 and Figure 41. Through visual inspection, the growth of water hyacinth was prominent at all locations and can be seen in Figure 42–48.

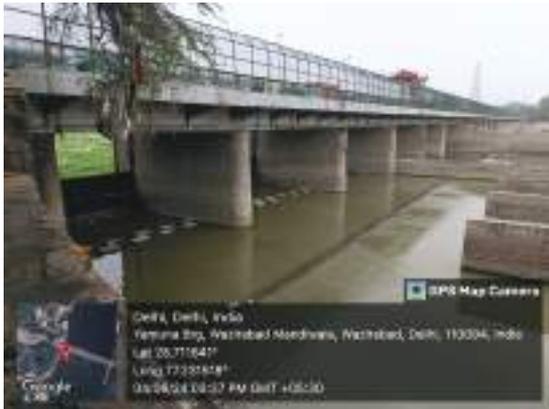
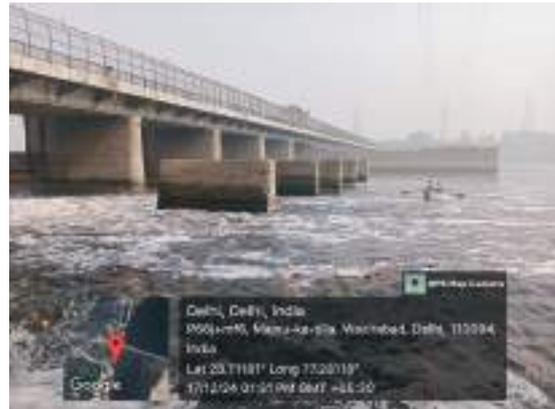
Figure 43: Pre and Post monsoon sampling at Downstream Wazirabad barrage

Pre-monsoon

Post-monsoon

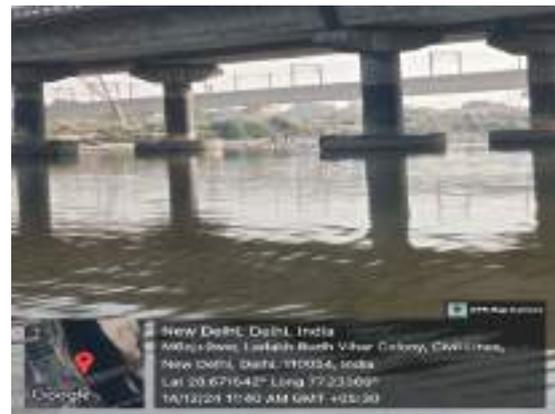
Figure 44: Pre and Post monsoon sampling at Hathi ghat

Post-monsoon

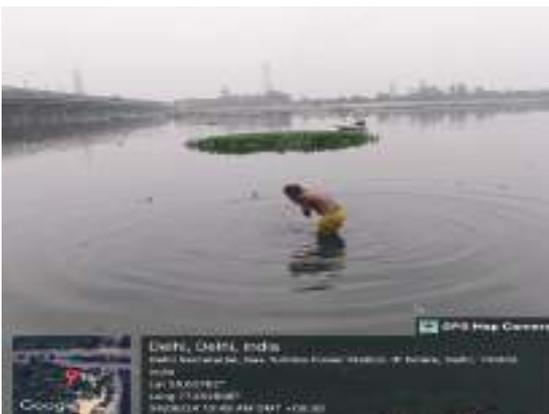
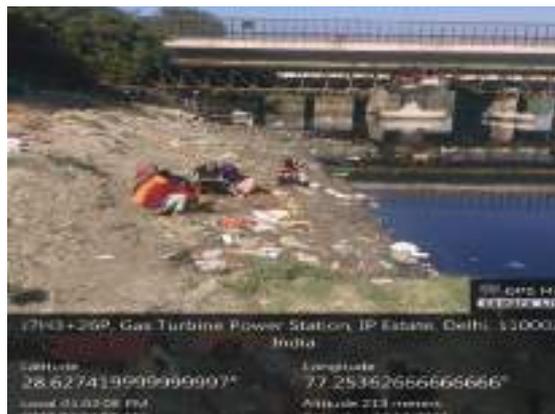
Figure 45: Pre and Post monsoon sampling at Chhath Ghat

Pre-monsoon

Post-monsoon

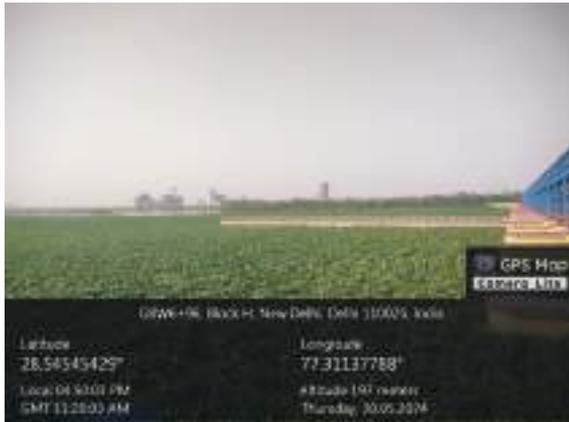
Figure 46: Pre and Post Monsoon Sampling at Upstream Okhla Barrage

Pre-monsoon

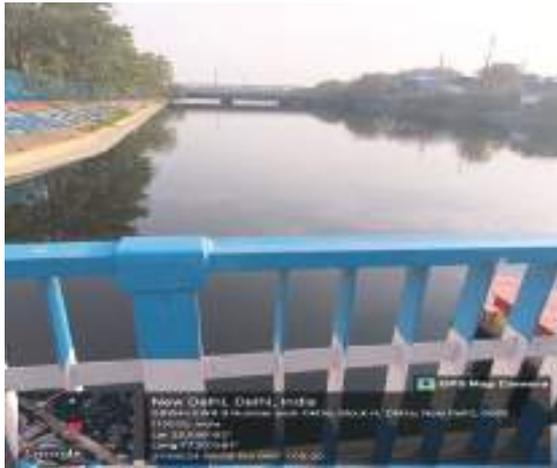
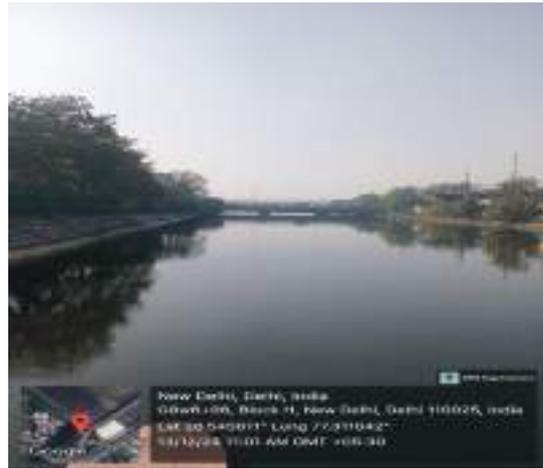
Figure 47: Pre and Post Monsoon Sampling at Agra Canal

Pre-monsoon

Post-monsoon

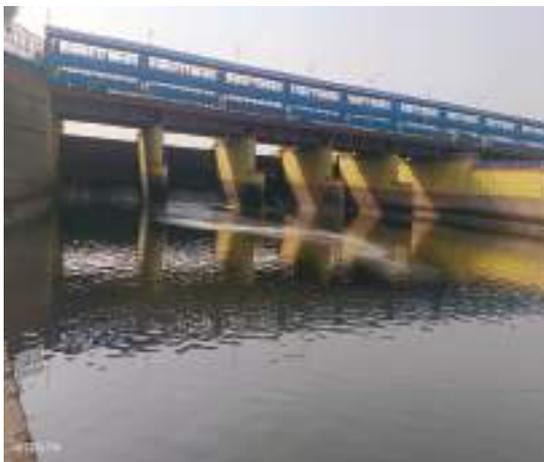
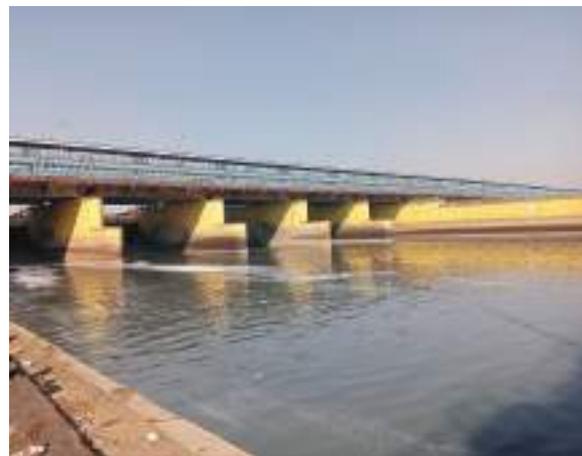
Figure 48: Pre and Post Monsoon Sampling at Downstream Okhla Barrage

Pre-monsoon

Post-monsoon

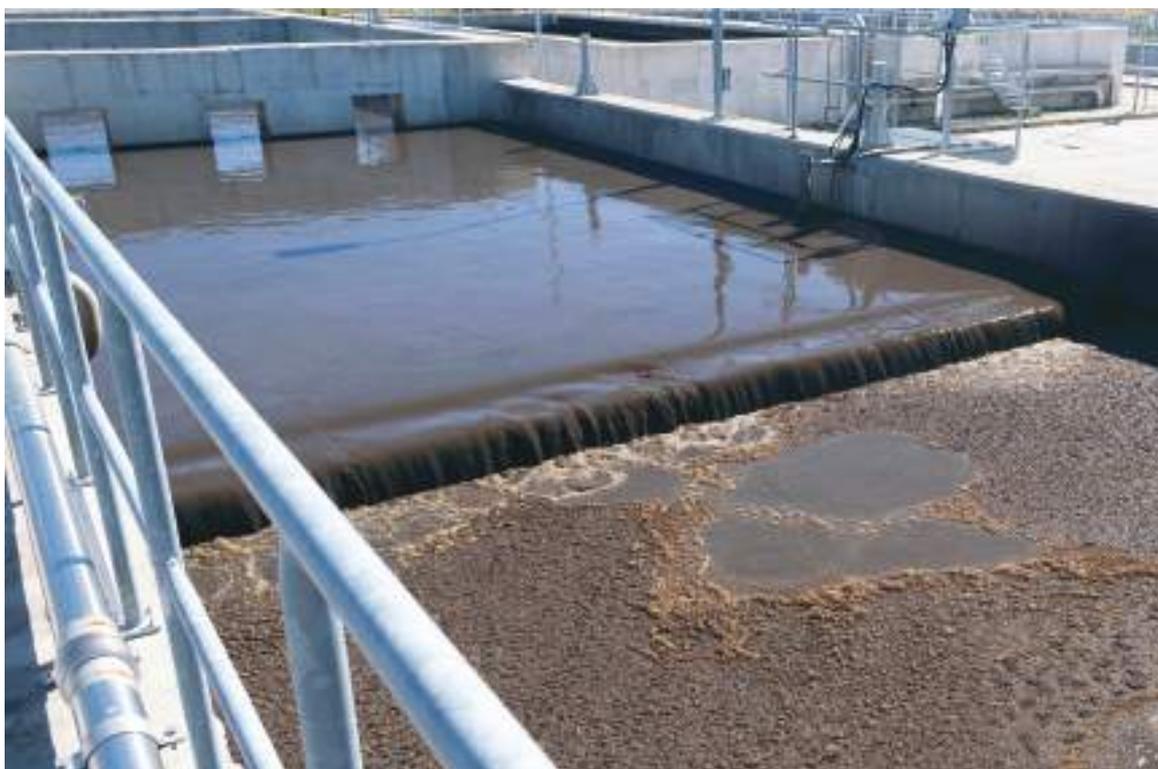
Figure 59: Sewage Treatment Plant

While STPs and CETPs were established to mitigate wastewater discharges, they show uneven distribution and limited efficiency across Delhi. A total of 39 STPs are mapped in the city, but their placement does not adequately correspond with the highest density of polluting sources. Similarly, 13 CETPs cater to 17 approved industrial estates, yet they often operate below capacity or inconsistently, failing to meet prescribed standards. The mismatch between the geographic spread of polluting industries and the available treatment infrastructure underscores a structural gap in wastewater management. Despite expansions in capacity, the sewage treatment deficit remains severe, with nearly 142 MGD of sewage still flowing untreated into the Yamuna through 22 major drains, against a total wastewater generation of approximately 800 MGD

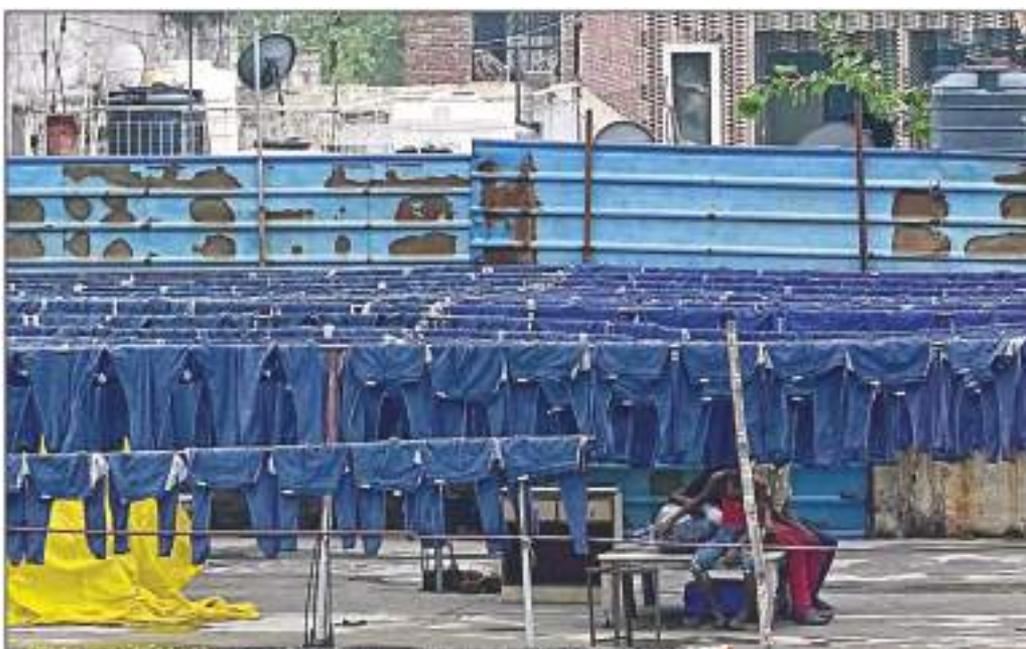
Figure 62: Illegal Dying units in Meethapur⁵

This case study examines the environmental and health impacts of illegal denim dyeing units operating in Meethapur village, located near the Delhi–Mumbai Expressway in southeast Delhi. Although these units are hidden behind locked gates, evidence of their activities can be observed through freshly dyed jeans drying on rooftops and drains running deep blue with untreated effluents. The dyeing process, while producing fashionable blue denim, is highly resource-intensive and environmentally unsustainable. It consumes thousands of litres of water and relies on synthetic indigo dye, which does not dissolve naturally and must be treated with strong chemicals such as hydrochloric acid, hydrogen peroxide, sulfuric acid, caustic soda, formic acid, surfactants, and salts. Without effluent treatment plants, these units discharge their chemical-laden wastewater directly into the village drains, which eventually converge into Bhatte Johad pond and later find their way into the Yamuna River.

The discharge of such toxic effluents has had multiple environmental consequences. The drains and pond in Meethapur have turned visibly blue, while contaminated wastewater has seeped into the soil and groundwater. The presence of heavy metals, carcinogenic substances, and phosphates not only deteriorates water quality but also contributes to the foaming and frothing observed in certain stretches of the Yamuna. Colloidal matter and chemical residues increase turbidity, inhibit sunlight penetration, and reduce the self-purifying capacity of the river. These factors have severely disrupted aquatic ecosystems and undermined the carrying capacity of the Yamuna.

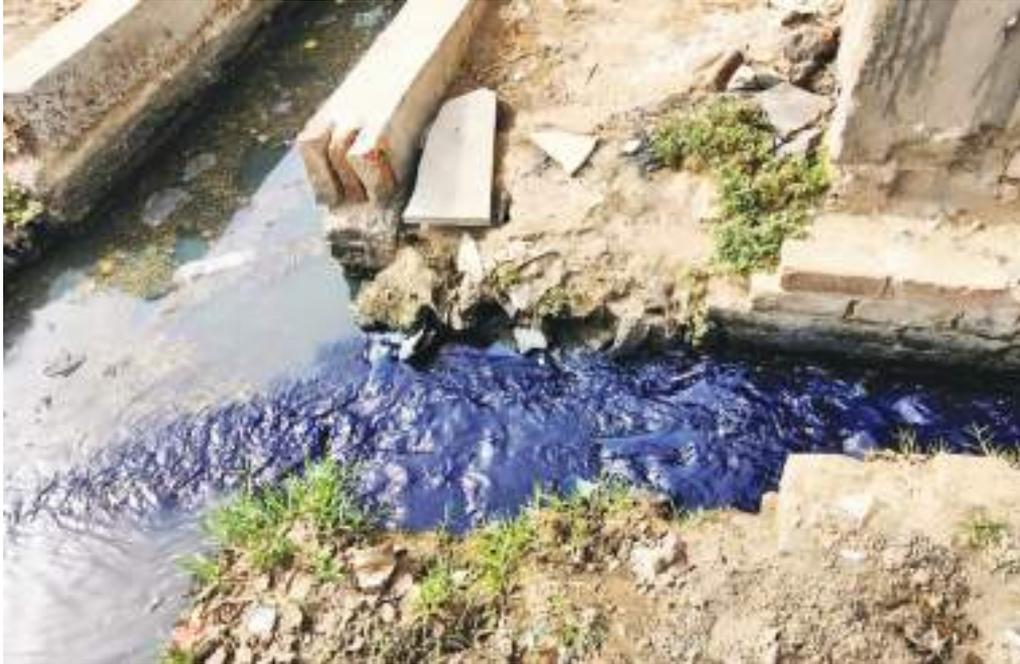
Figure 63: Drain in Shiv Vihar Carrying Dye Effluent³⁵

This case study examines the environmental and health impacts of illegal denim dyeing units operating in Shiv Vihar, East Delhi, and adjacent Shanti Nagar in Uttar Pradesh. While these factories were officially sealed following Delhi High Court orders and a Central Bureau of Investigation (CBI) inquiry into regulatory lapses, evidence of their activities persists. Though their front entrances remain shut and sealed, hidden backdoors in adjoining lanes of Uttar Pradesh allow operations to continue. The drains in Shiv Vihar still run deep blue the unmistakable pigment of denim dye indicating ongoing effluent discharge.

The dyeing process, while producing the globally popular blue denim, is highly resource-intensive and environmentally destructive. It requires thousands of litres of freshwater and the use of synthetic indigo dye, which is not naturally soluble and therefore treated with hazardous chemicals such as hydrochloric acid, hydrogen peroxide, sulfuric acid, caustic soda, formic acid, surfactants, and salts. With no effluent treatment plants (ETPs) in place, the untreated wastewater is discharged directly into narrow drains that flow into the Yamuna River. The continued discharge of effluents from these units has turned local drains visibly blue and caused severe contamination of both surface and groundwater. Heavy metals, persistent organic compounds, and phosphates present in the wastewater not only degrade water quality but also contribute to foaming and frothing observed in certain stretches of the Yamuna.

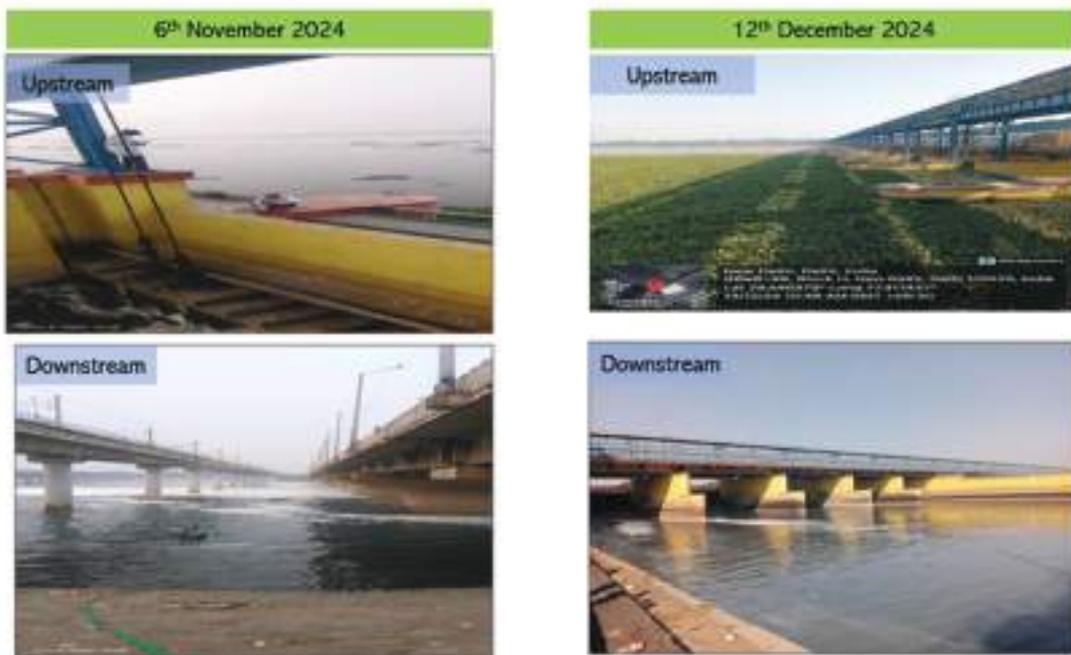
Figure 70: Upstream and Downstreams of Okhla Barrage Observed on Various Sampling Dates (Contd.)

Visual documentation of the site across different dates demonstrates this seasonal variability in both upstream and downstream conditions shown in Figure 69-70. On 30th May 2024 and 26th July 2024, the upstream region is visibly clogged with dense growth of water hyacinth, indicating prolonged stagnation and eutrophication.

However, by 25th October 2024, upstream hyacinth has been cleared, and correspondingly, the downstream area exhibits intense foaming—suggestive of the release of accumulated organic matter. This foaming condition is extreme and widespread again on 6th November 2024, when water is visibly frothy under the barrage bridge and farther downstream.

The situation moderately improves by December 2024, but the reappearance of hyacinth on the upstream, and accumulation occurs. The pollutant parameters analysed for upstream and downstream of Okhla Barrage River water samples have been provided in Table 19–20, and analysis of results have been provided in Figure 71–72.
